Easel X-Axis offset when tiling

Description

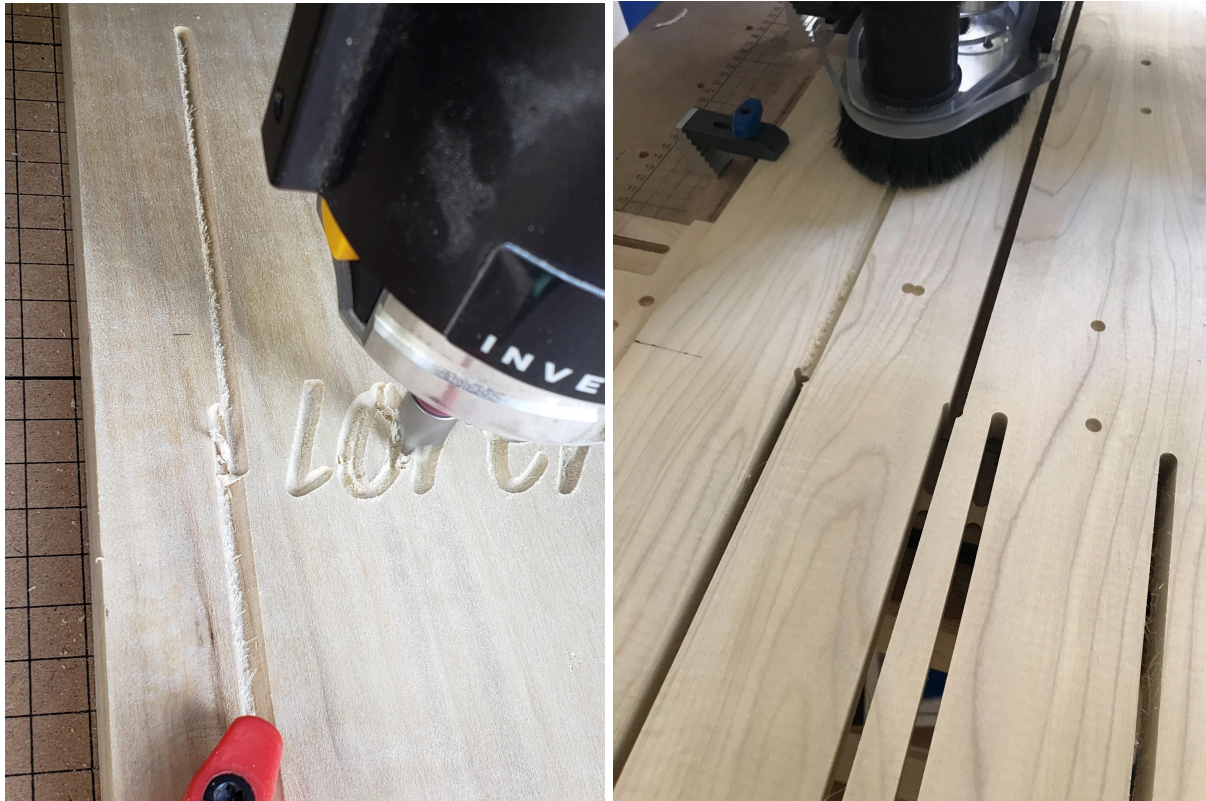
When carving a tiled project, people have experienced misaligned toolpaths when shifting materials between tiles. Vertical toolpaths are not aligned on the x-axis at the title boundary. This happens when using last work zero position.

We have initially thought this to be a software issue. Through testing in Easel we have realized the toolpaths sent to the machine were correct, but the material was not lined up correctly between carved. Even small deviations between how the material is aligned propagate to large values when material is large enough.

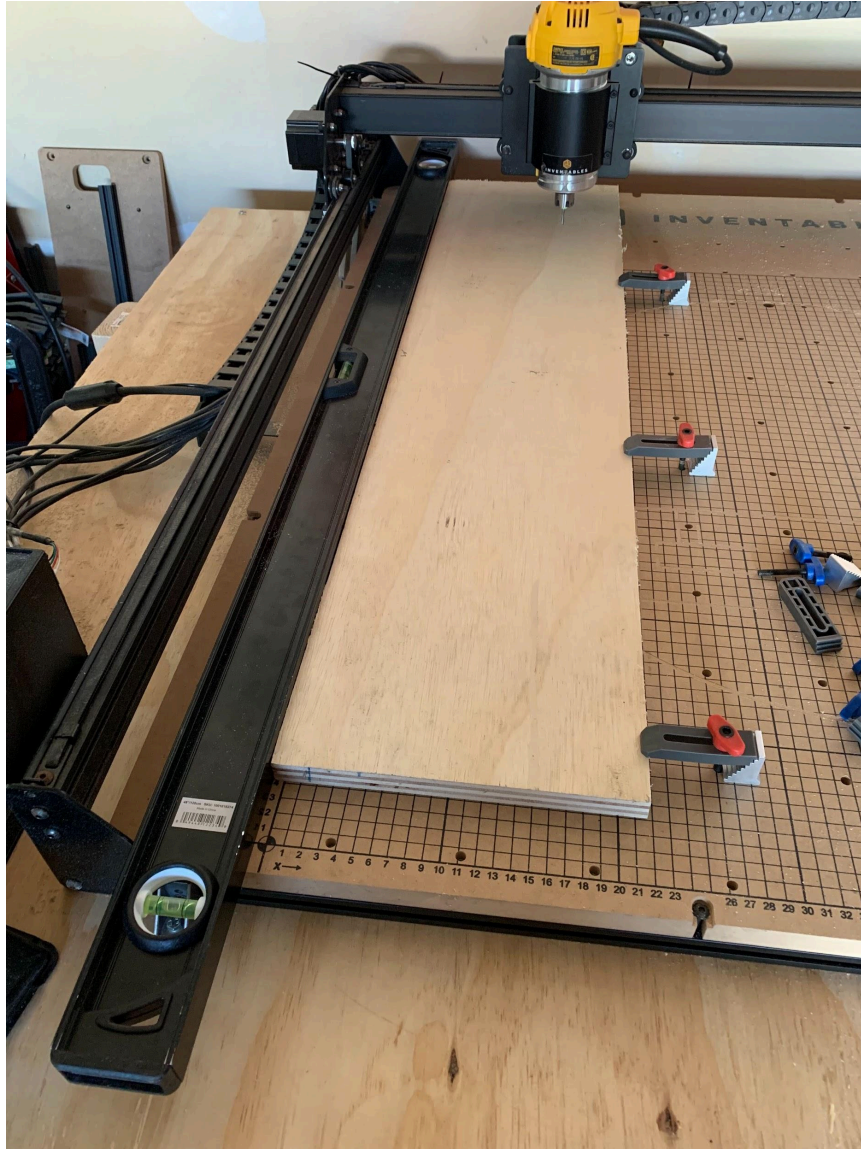
Second problem seems to not be such an issue for a lot of our users who assume the gantry and machine frame are perfectly square. Here is one of the example setups with 48" long level bumped against the machine frame, which might not be perfectly square with the gantry

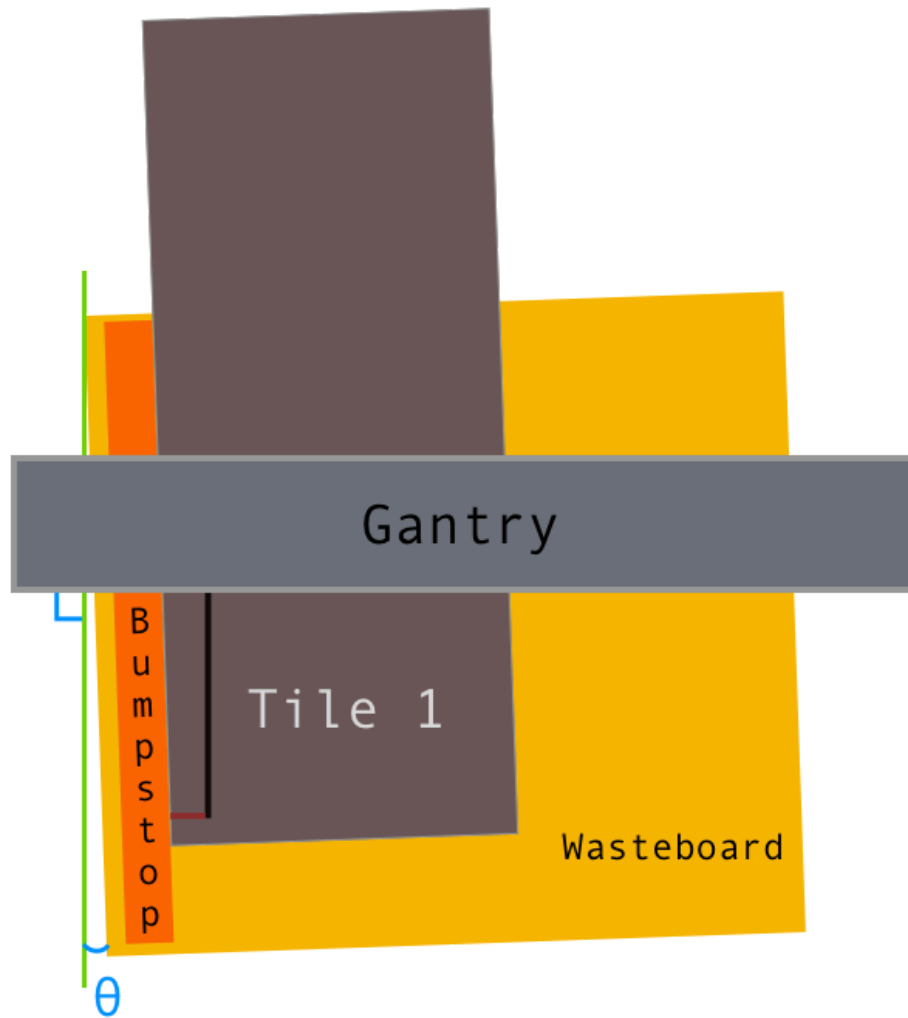
Drawing below shows how the angle relates to the machine and material. The rectangle below represents the material tilted from the gantry squareness.

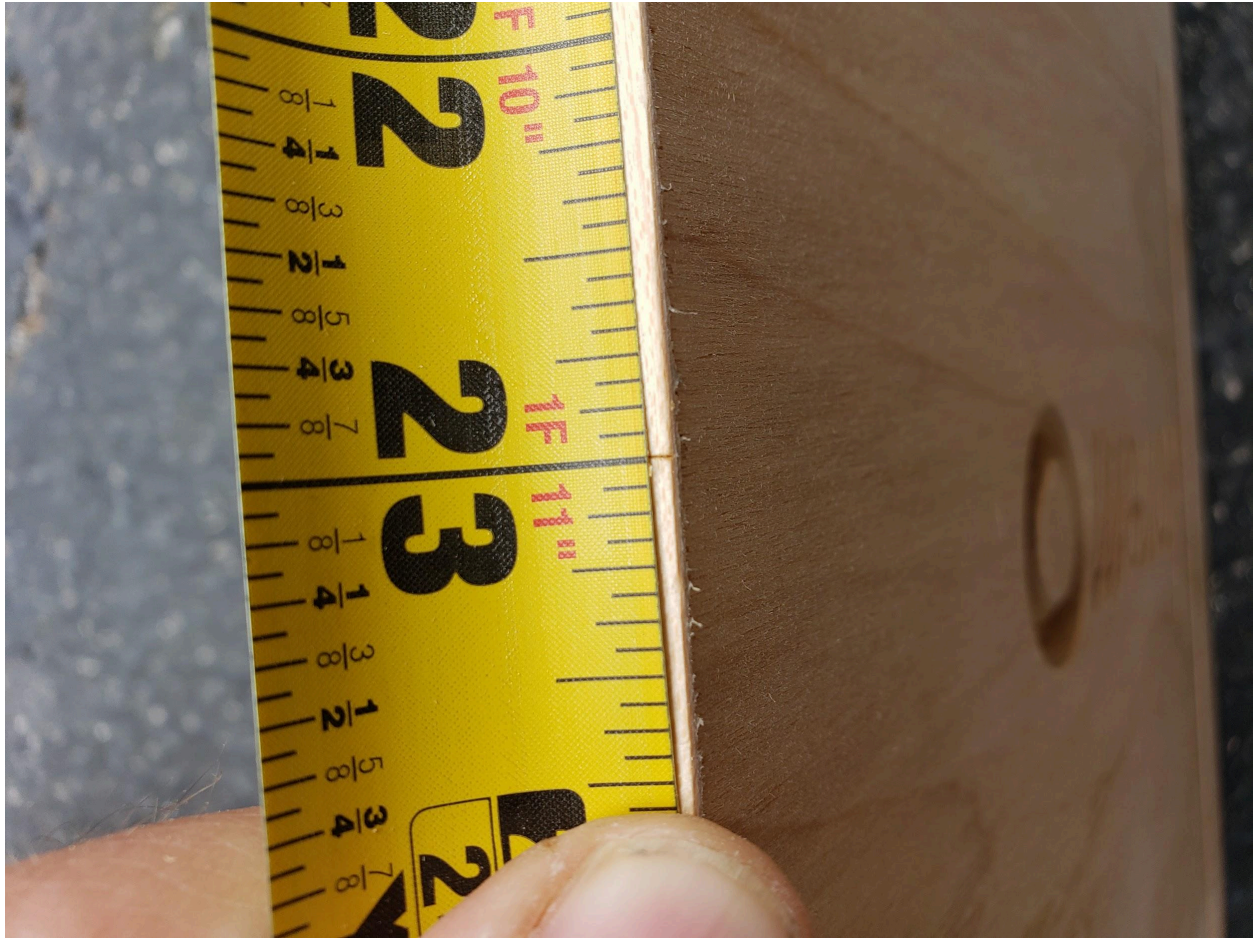
Marking the edge of material for alignment.

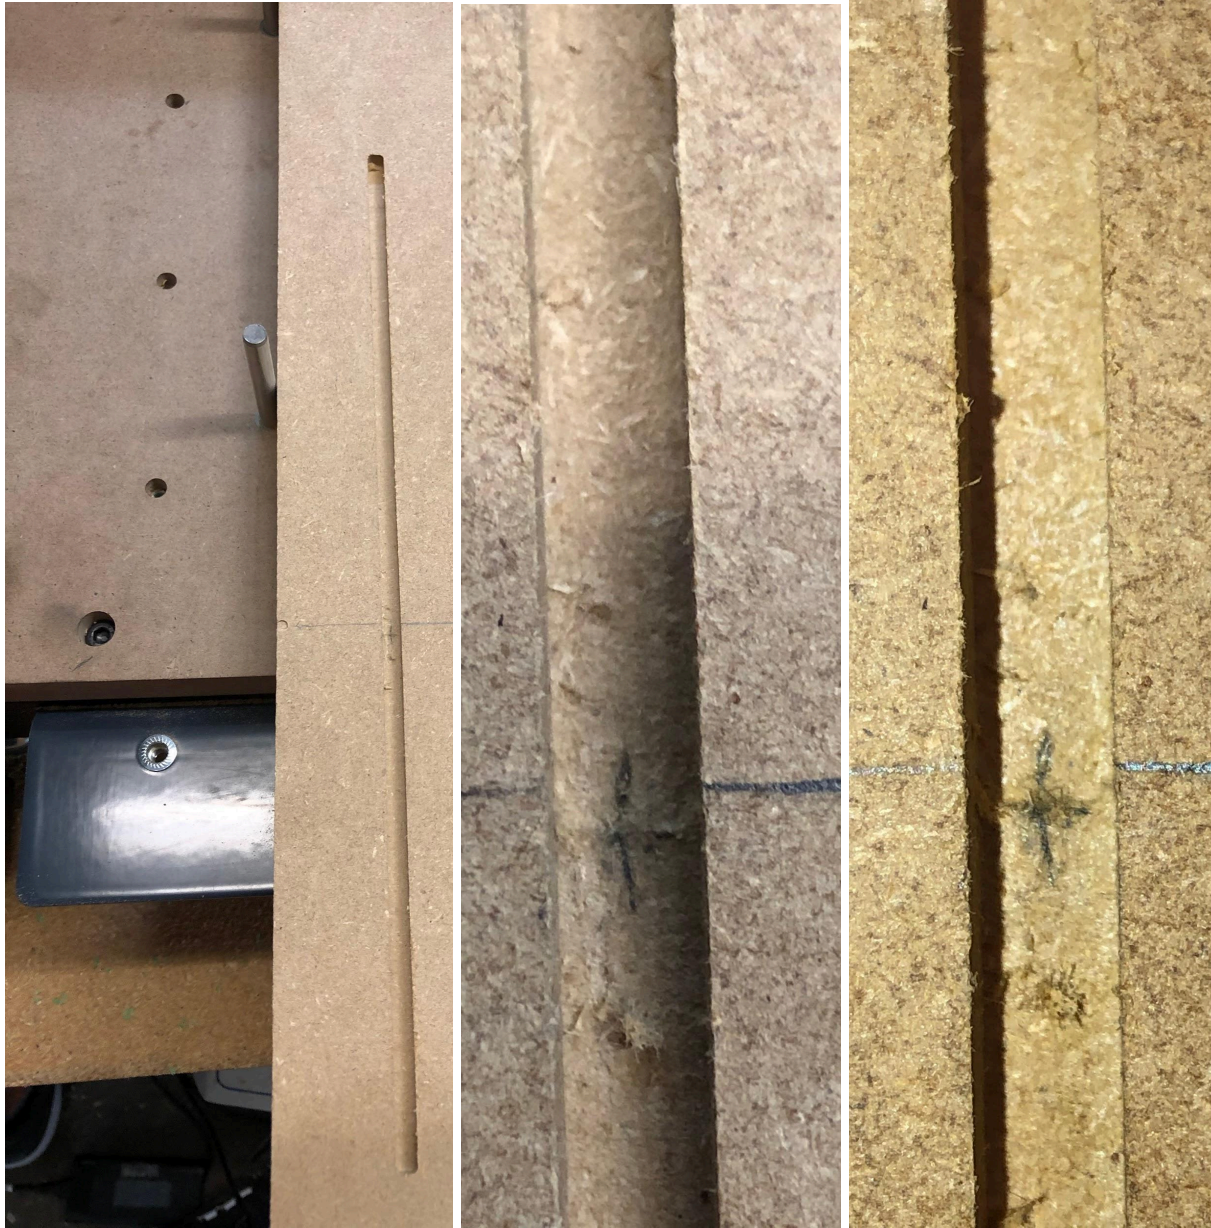
$\frac{1}{8}$ " Bit, the horizontal line is where the tiles intersect

- Both the $\frac{1}{8}$ " bit and V-Carve bit has little to no deviation when tiled at 6" tiles
- Furthermore, the V-Carve bit test had one tile at 5 pins and that showcased a little to no deviation as well.

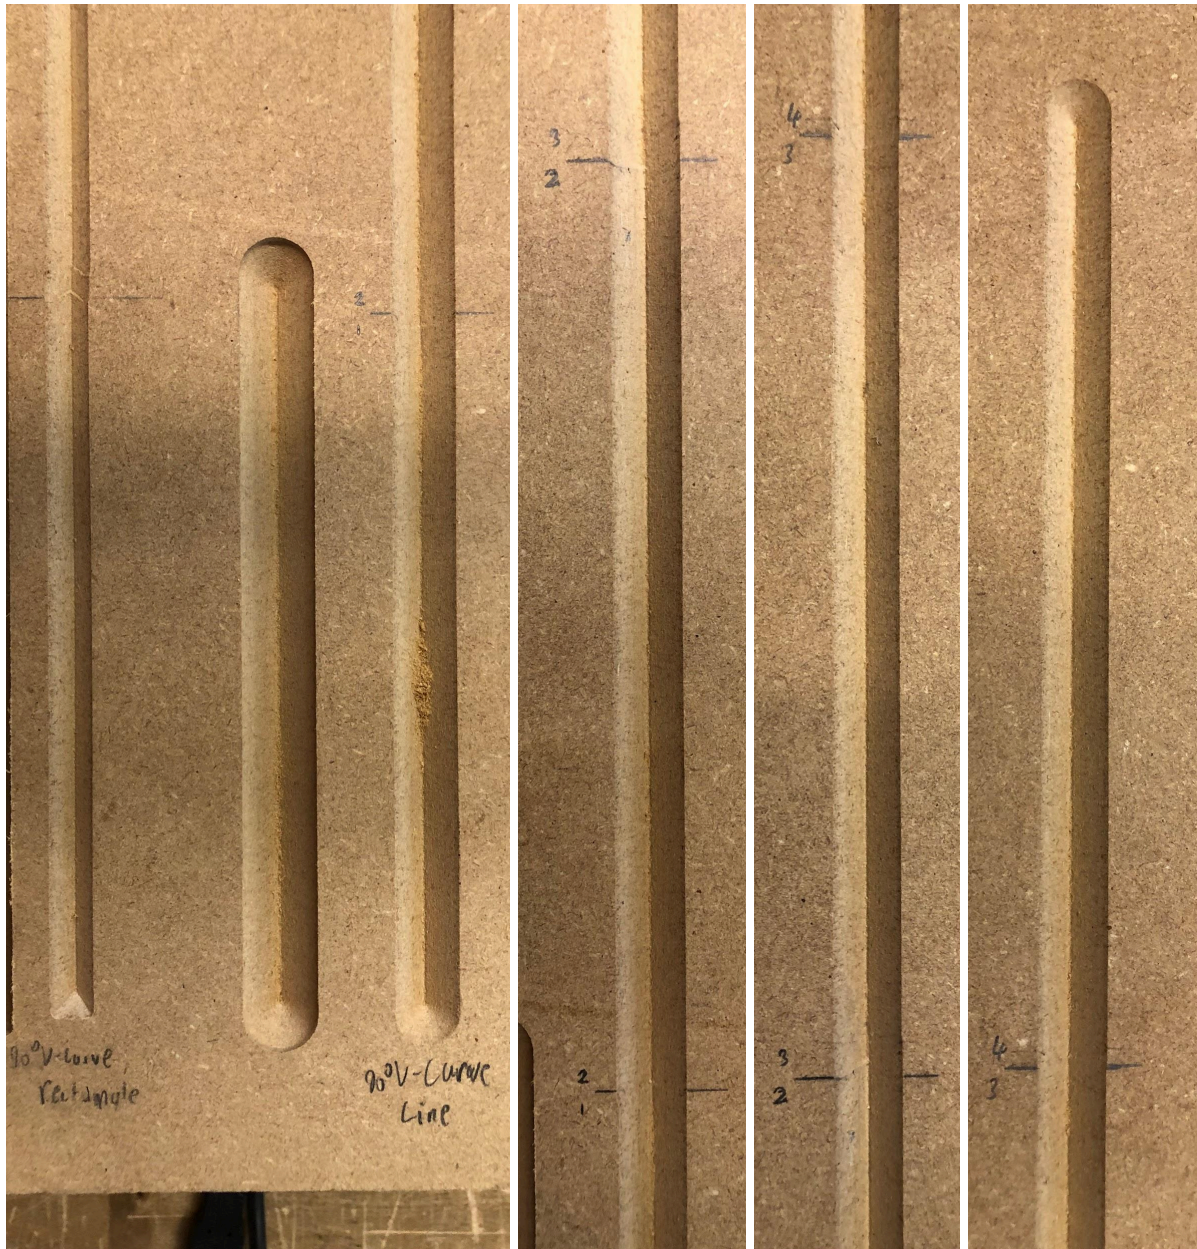
90 Deg V-Carve Bit, the horizontal lines are where the tiles intersect (Left line is a Rectangle on Easel and right line is a Line on Easel)
